Appendix A

Summary and Evaluation

Rubblized Pavement Test Results

**Federal Aviation Administration
National Airport Test Facility**

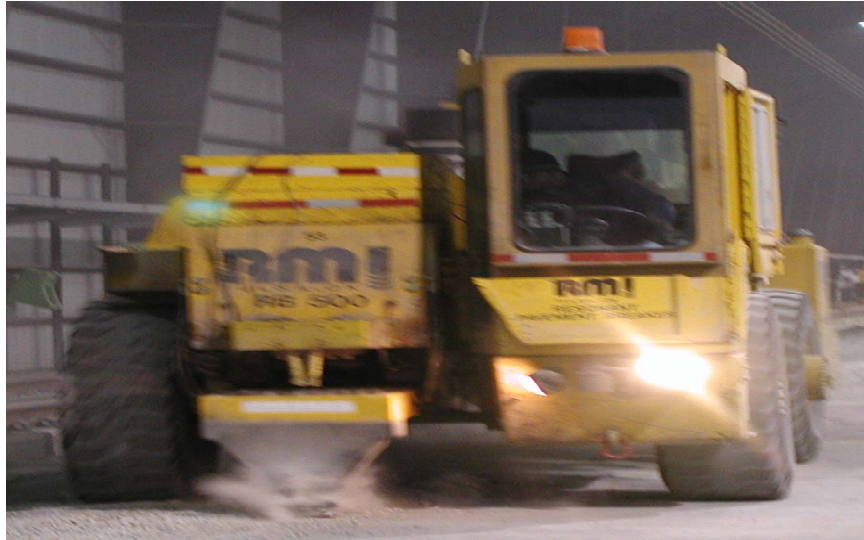
FIGURE 1

RMI Resonant Breaker

In January 2005, all of the 12-inch concrete slabs in the north CC-2 traffic lane, including transition slabs, were rubblized with an RMI RB-500 resonant breaker operating at 44 Hz from Hayhoe and Garg (2). The rubblized pavements were compacted with a steel wheel vibratory roller in June 2005. The south CC-2 traffic lane was not rubblized and both the north and south lanes were overlaid with 5-inches of P-401 hot mix asphalt (HMA) placed in two, 2.5-inch lifts. This allowed for observation of the comparative performance of the asphalt overlaid rubblized and non-rubblized concrete pavements during later trafficking. In this report, asphalt on rubblized concrete sections are referred to as ARC, while asphalt on non-rubblized concrete sections are referred to as APC. Figure 1, “RMI Resonant Breaker” and Figure 2, “Steel Wheel Vibratory Roller” depict the rubblizing and compaction equipment, respectively, that were used for the construction. A schematic of rubblized and non-rubblized test items is depicted in Figure 3, “Layout of Test Items at the NAPTF”.

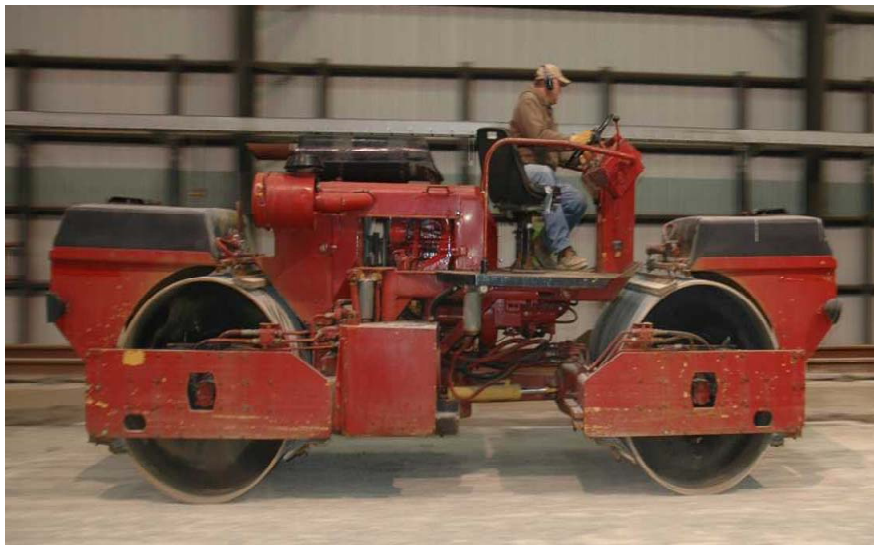
FIGURE 2

Steel Wheel Vibratory Roller

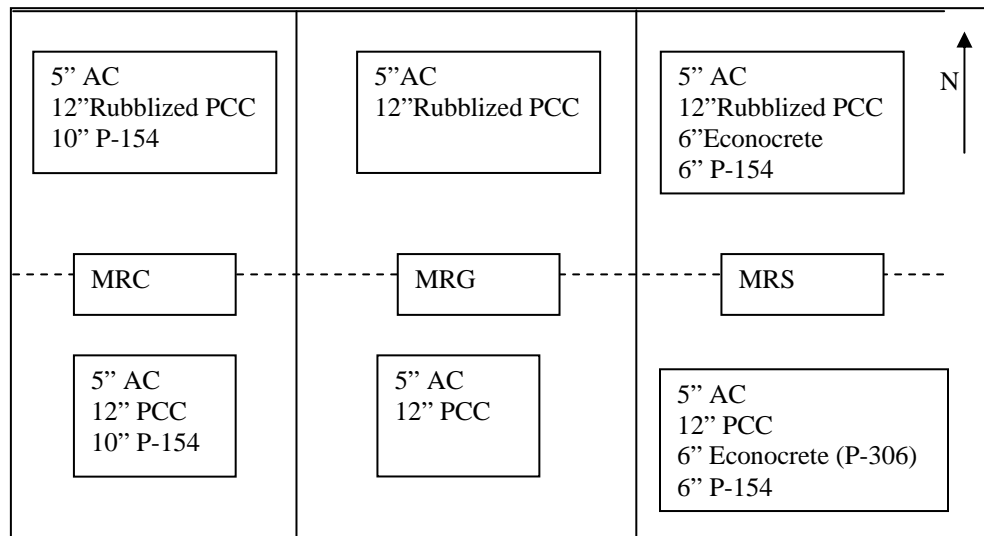
FIGURE 3

Layout of Test Items at the NAPTF

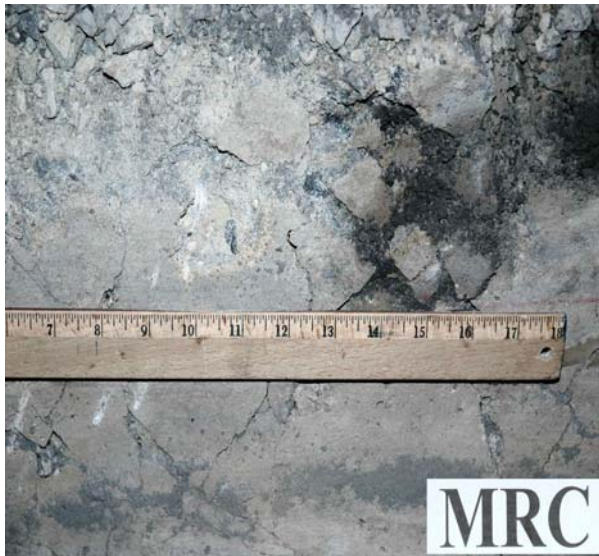
FIGURE 4

Rubblized Pieces in MRC

After the test items were rubblized, 4-ft. by 4-ft. test pits were cut in each test item to observe the rubblized concrete and to access subgrade and base layers for testing. Photos depicting fracture patterns and particle sizes of the rubblized concrete on MRC, MRG, and MRS are depicted in Figure 4, "Rubblized Pieces in MRC", Figure 5, "Rubblized Pieces in MRG", and Figure 6, "Rubblized Pieces in MRS", respectively. Figure 7, "Surface of Rubblized Pavement in MRS" depicts the typical condition of the pavement surface after rubblizing and compaction. The test pits indicated that the top 2 inches to 3 inches of the rubblized concrete was rubblized to particle sizes of 1-inch to dust. The particle sizes in the bottom 9 inches generally ranged from 4 inches to 15 inches with the larger particle sizes in the MRS section.

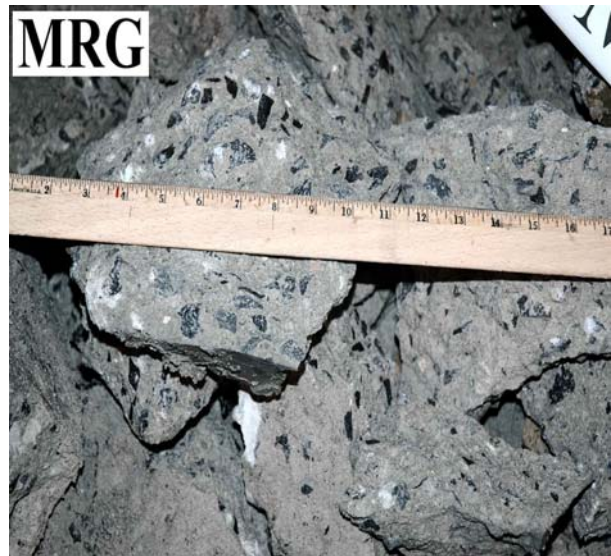
FIGURE 5

Rubblized Pieces in MRG

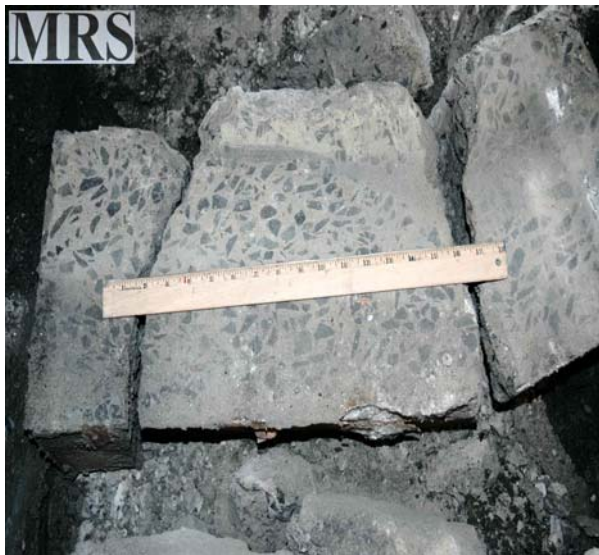
FIGURE 6

Rubblized Pieces in MRS

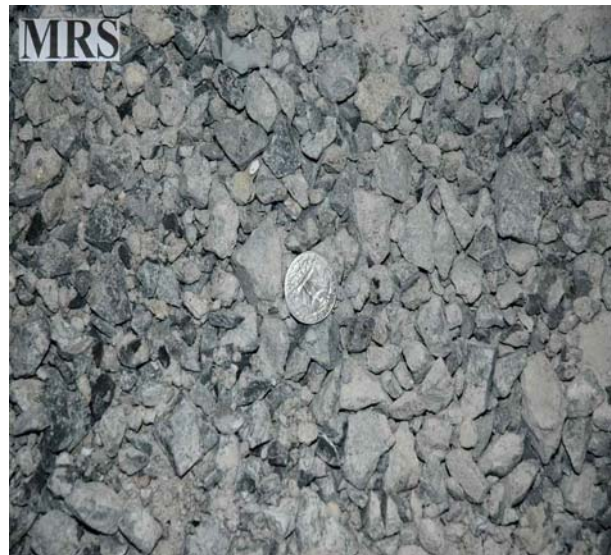
FIGURE 7

Surface of Rubblized Pavement in MRS

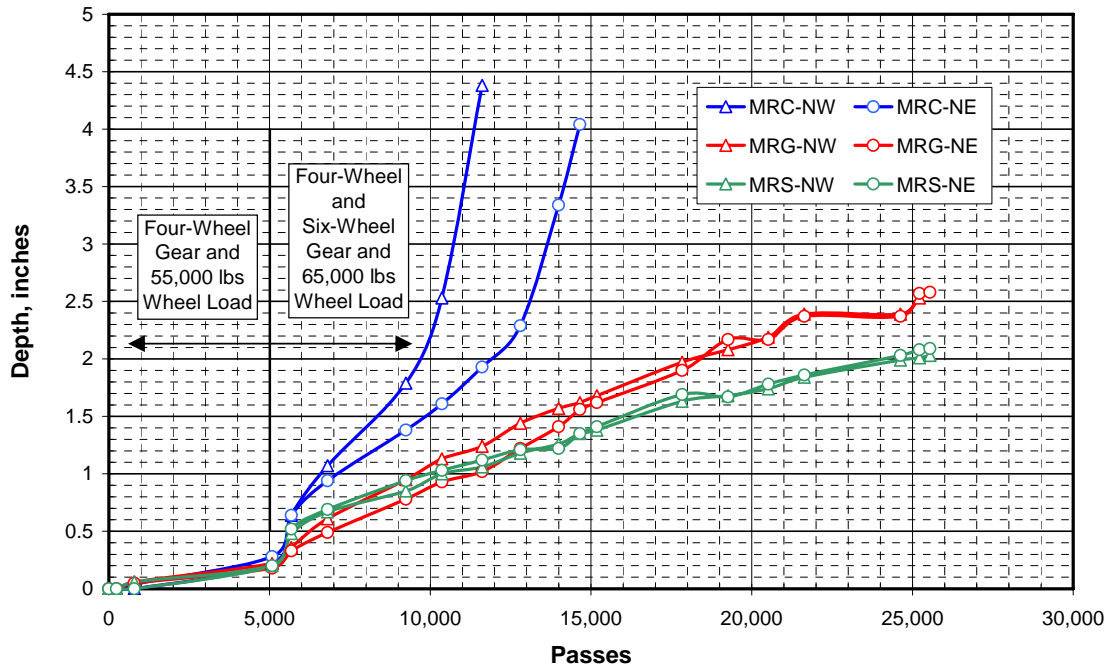
FIGURE 11

A comparison of the relative performance of the three rubblized (ARC) test items is shown in Figure 11, “Comparative Performance of Rubblized Test Items”. As shown, rut accumulation was highest for the MRC rubblized test item, followed by the MRG and MRS items, respectively. As discussed later, the relatively poor performance of the thicker MRC test item as compared to the thinner MRG test item is believed to be due to differences in subgrade strength. (see Section 3.0 and Section 7.0).

Comparative Performance of Rubblized Test Items

In reviewing Figures 8 through 11 and Appendix A.4 one may be concerned with the rather large rut depths depicted in the figures. To understand this, one must first understand the FAA and military definition of failure for flexible pavements, which is shear failure in the subgrade, assumed to occur with a 1-inch upheaval in subgrade from loading. This was also the definition used for the multi-wheel heavy gear load (MWHGL) and prior tests conducted by the military in the 1940s, 1950s, and 1960s, which are the basis for the current FAA and military flexible design criteria. Therefore, it is often necessary to incur large surface ruts to ensure invoking the subgrade shear failure criteria.

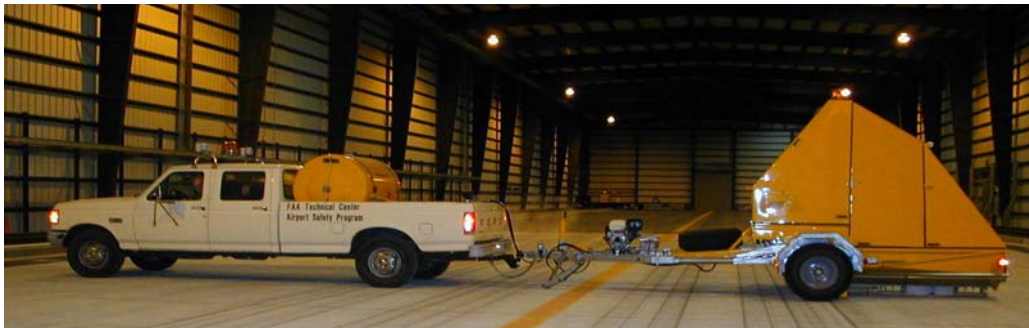
FIGURE 12

Prior to trafficking and at periodic intervals during trafficking HWD tests were performed with the FAA's KUAB HWD, which is depicted in Figure 12, "FAA's KUAB HWD". Tests were performed with the equipment's 12-inch diameter segmented load plate at nominal force amplitudes of 12,000 lbs., 24,000 lbs., and 36,000 lbs., and pavement responses measured at 12-inch offsets from the center of the load plate out to 72 inches. The load response data at each test location represent the deflection basin, which can be used with either closed-form or layered elastic back-calculation procedures to compute the elastic moduli of pavement and subgrade layers. For this study, the elastic modulus of the rubblized layer (E_r) was of primary interest, since E_r would be an input to a mechanistic design procedure, such as FAA's LEDFAA layered elastic design program.

FAA's KUAB HWD

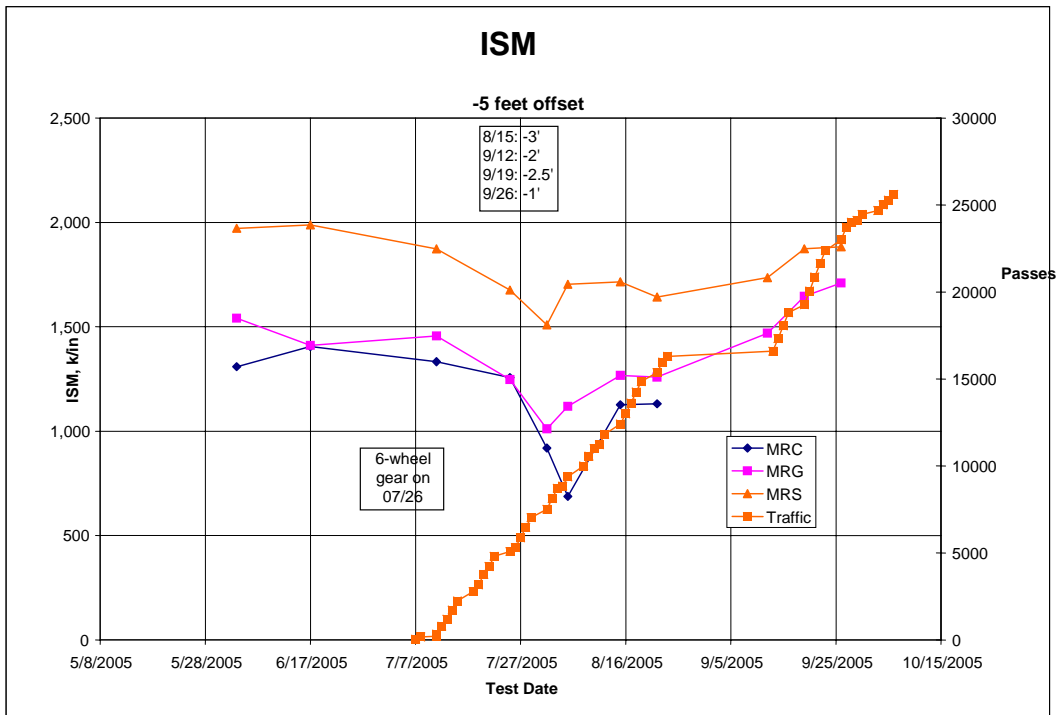
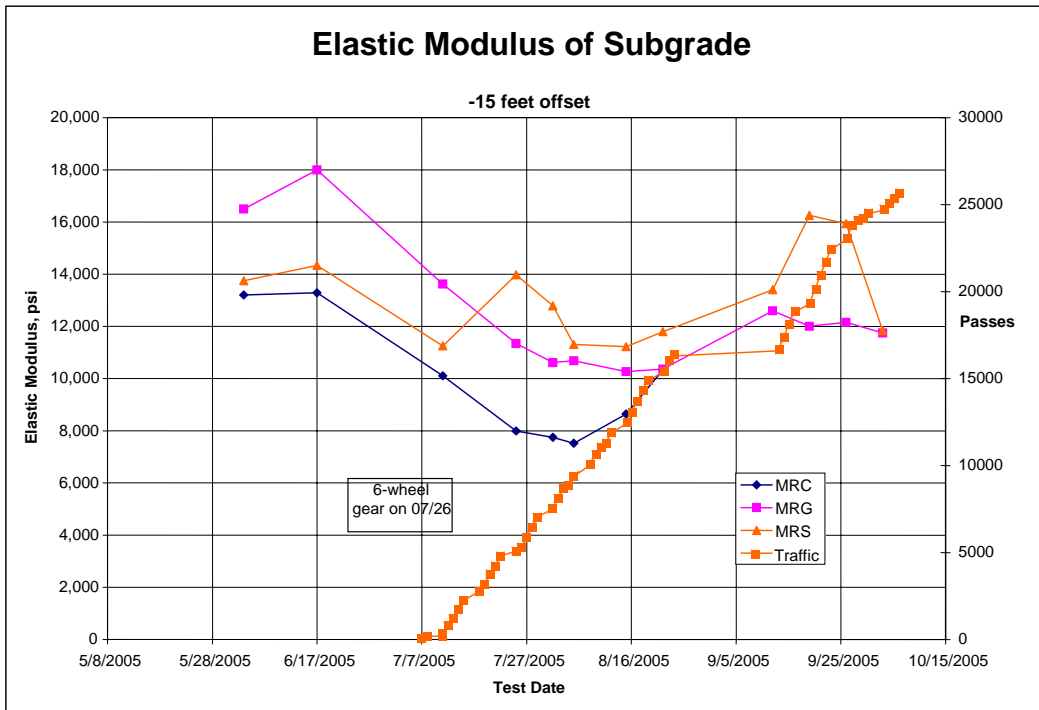
HWD tests were performed at periodic intervals during trafficking to detect any variations in pavement support conditions with loading. The following figures summarize the results during trafficking for ISM, rubblized layer E_r and subgrade E at the 5-ft. and 15-ft. offset:

The back-calculation results were from the 24,000 lbs. force using FAA’s BACKFAA program.

Similar results were obtained with the WESDEF program.

It should be noted that the HWD offsets were varied in steps from 5-ft. to 1-ft. after the “dip” in ISM and E_r to avoid the more severely rutted area (see Appendix A.4 for Transverse Profile Plots). In this case, moving the HWD locations from rutted to less rutted areas could explain the variations of ISM and E_r for the -5-ft. offset results.

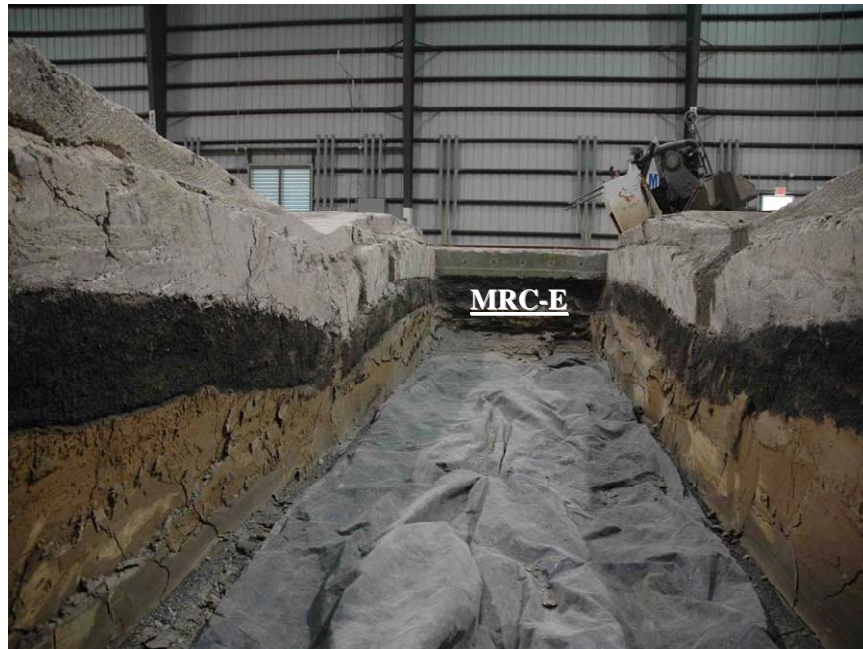
FIGURE 19

Figure 19, “MRC Trench – East End”, and Figure 20, “MRC Trench – West End”, depict the condition of pavement and subgrade layers for ARC pavements in the MRC test item. Figure 21, “MRG Trench”, and Figure 22, “MRS Trench”, depict ARC pavements in the MRG and MRS test items. As shown, more rutting and layer deformation was observed in the MRC test item. Figure 23, “Close-Up of MRC Failure” is a close up of subgrade intrusion into the P-154 subbase on the MRC test items. From inspection of the trenches, classical subgrade (shear) failure is believed to have occurred in MRC, but not necessarily in MRG, and MRS.

MRC Trench – East End

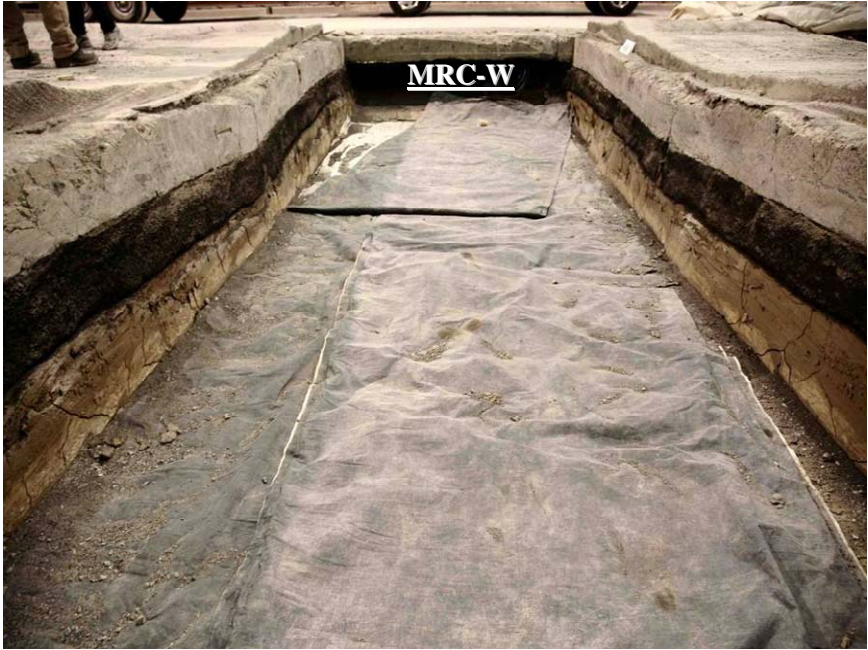
FIGURE 20

MRC Trench – West End

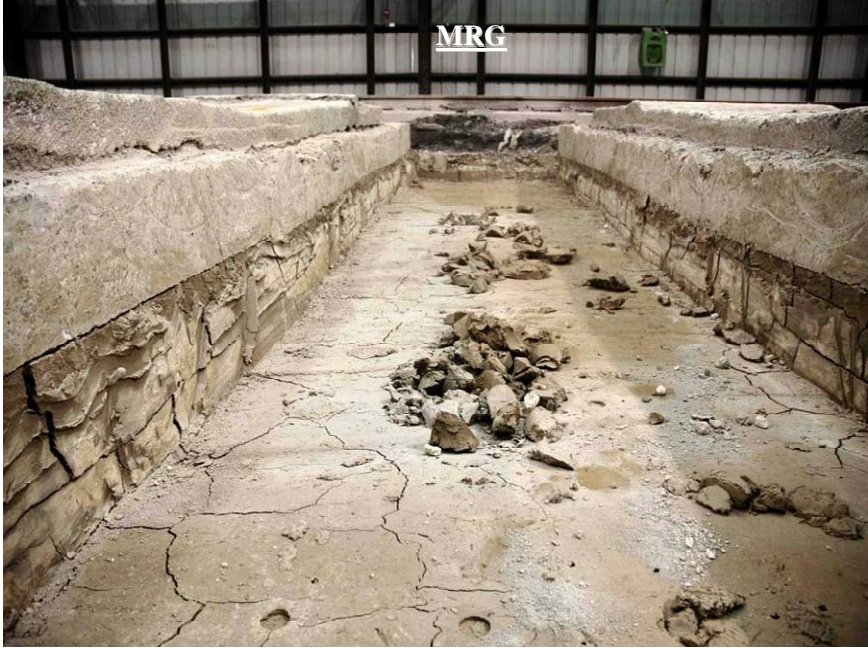
FIGURE 21

MRG Trench

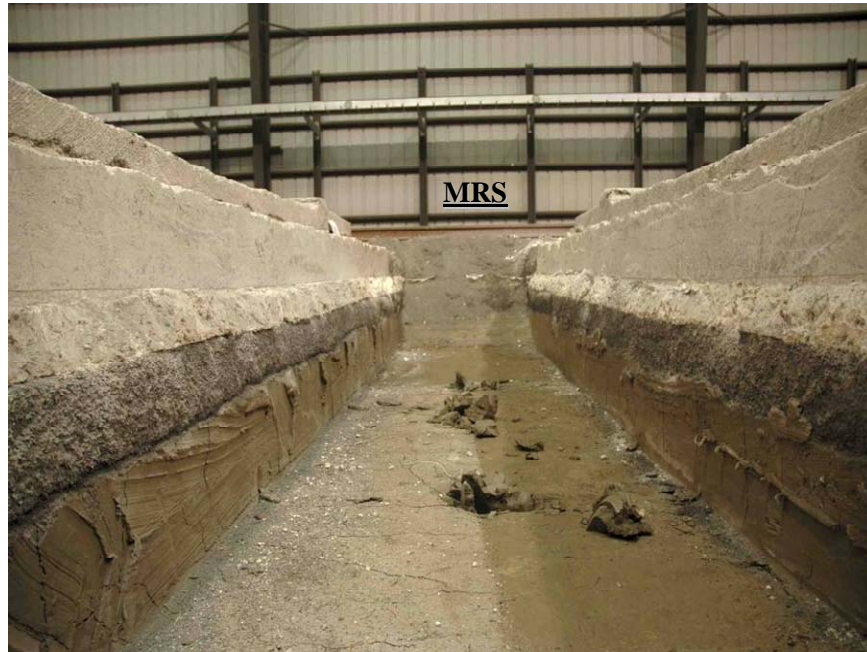
FIGURE 22

MRS Trench

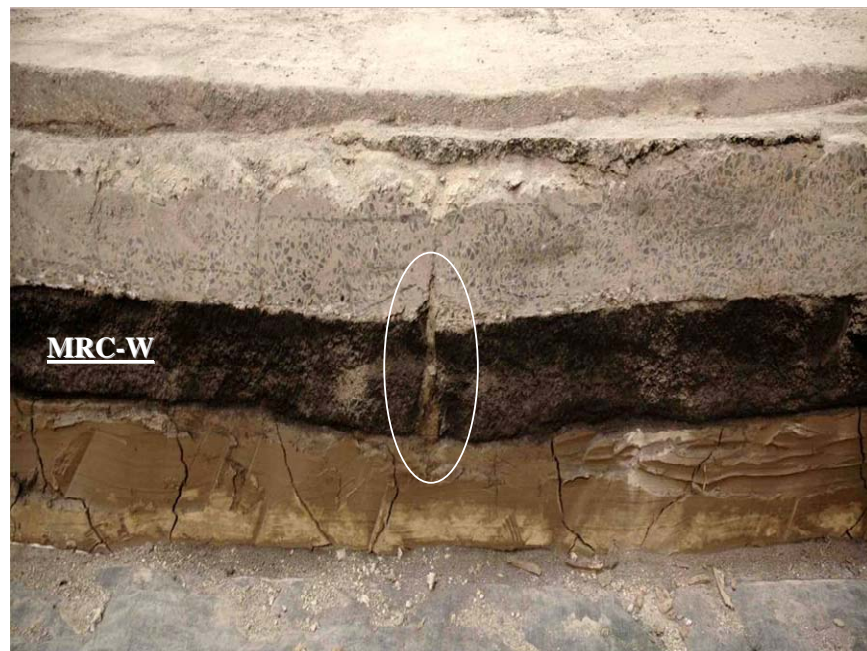
FIGURE 23

CLOSE-UP OF MRC FAILURE

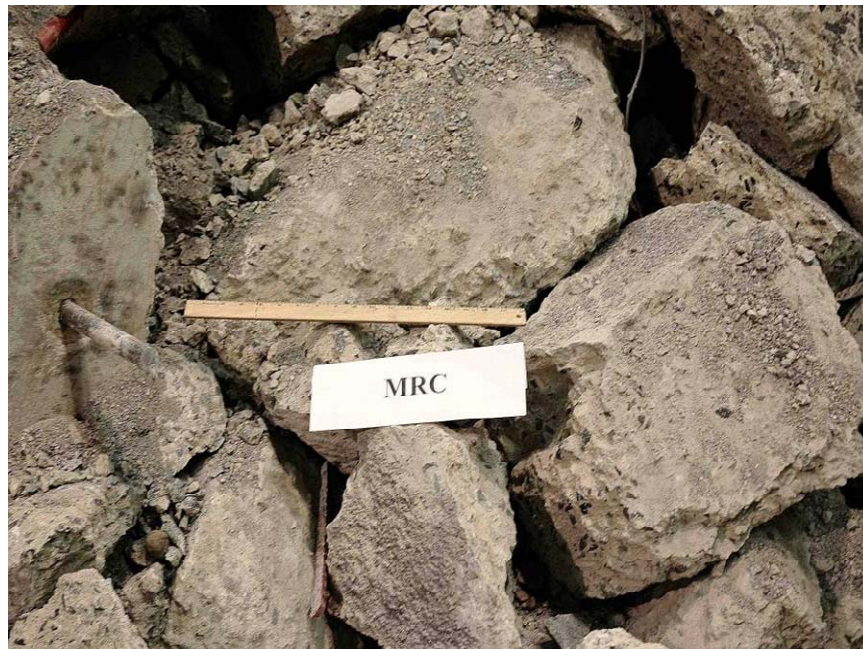
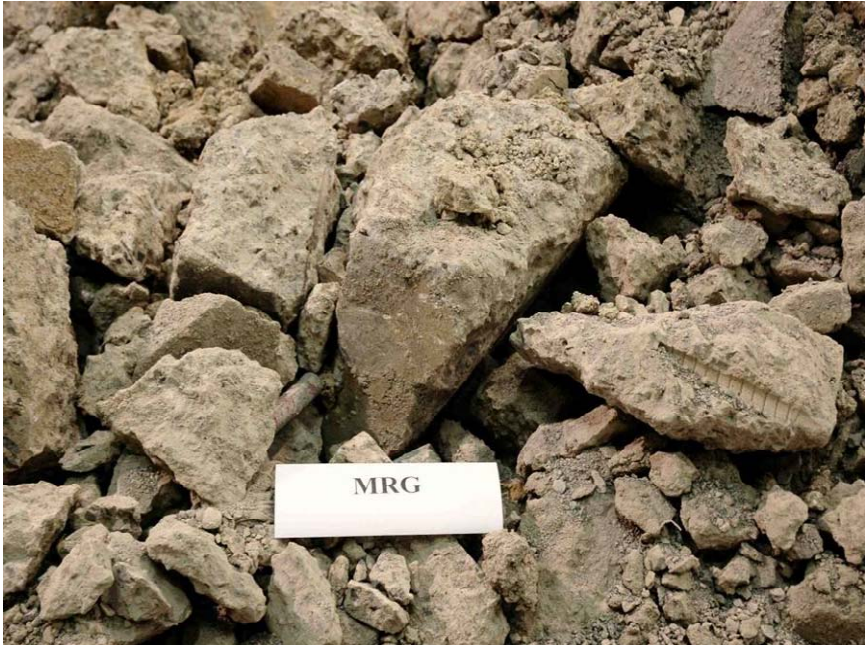
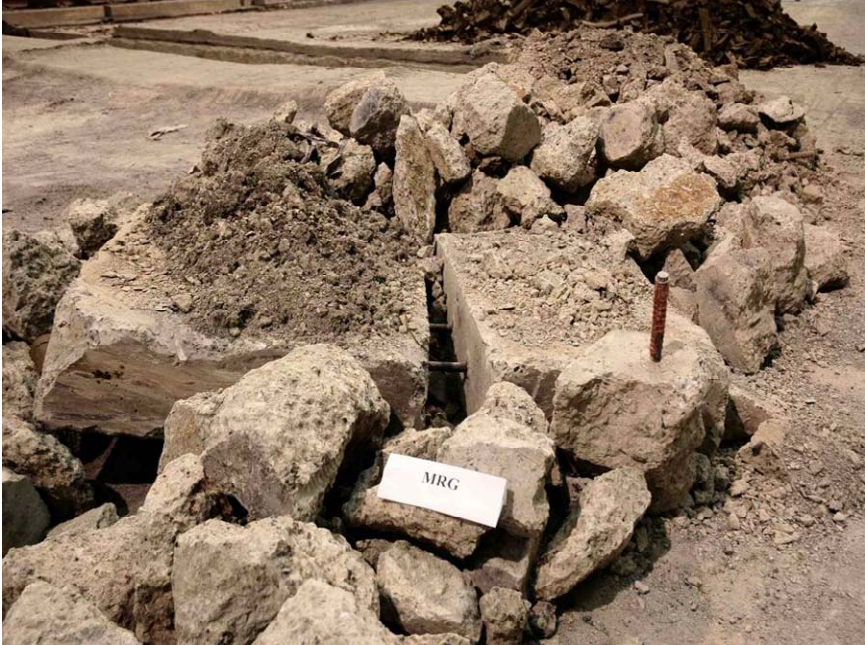
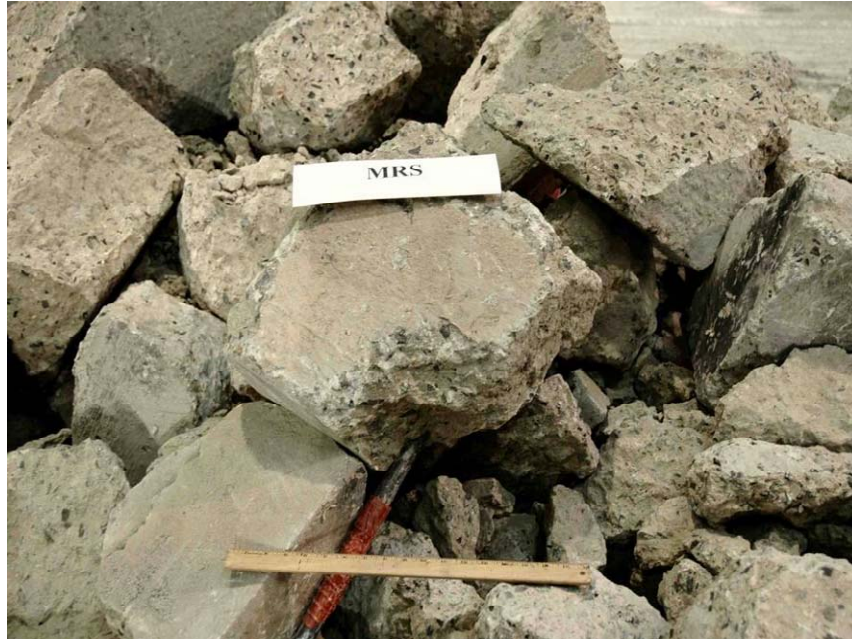
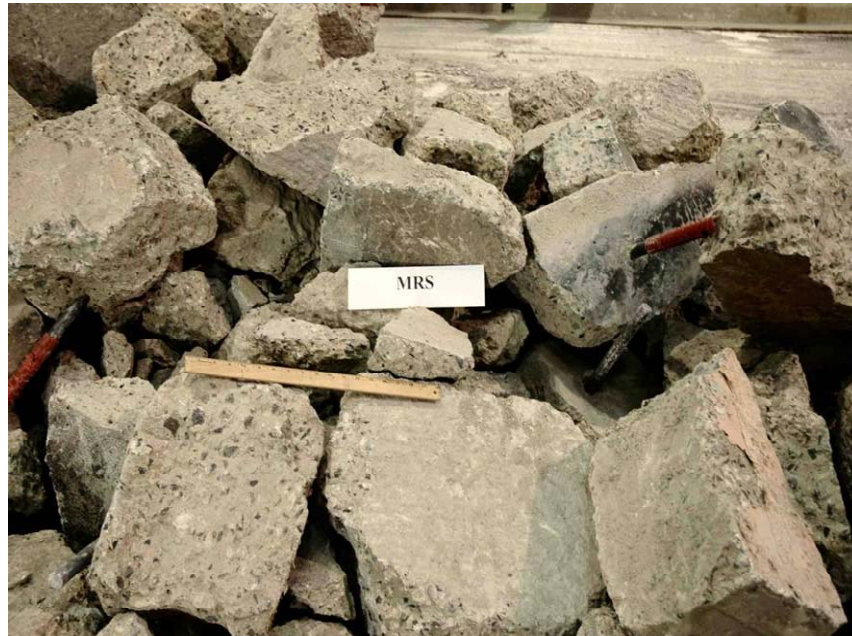
Figures 24 and 25, Figures 26 and 27, and Figures 28 and 29 depict the rubblized concrete pieces that were removed from the MRC, MRG and MRS test items, respectively. The largest pieces were observed in the MRS test items. Also note the embedded dowel bars in the rubblized concrete pieces, indicating that the rubblization did not fully debond the steel.

With respect to the procedures used to rubblize the concrete slabs, it is noteworthy that the resonant breaker did not damage the underlying concrete slab in the MRS test item (see Figure 30). However, the resonant breaker did not fully debond the dowels from the concrete (see Figures 24, 27, and 29). This could influence the performance of the rubblized layer in the field and, as discussed, may have influenced the HWD response data and back-calculated rubblized layer moduli. Also, rubblization with the resonant breaker resulted in relatively fine, aggregate size pieces in the top 3-inches of the test items and larger (9-inch to 12-inch) pieces in the bottom 9-inches. The ramifications of this on pavement performance may not be fully understood and are discussed in more detail in the main report.

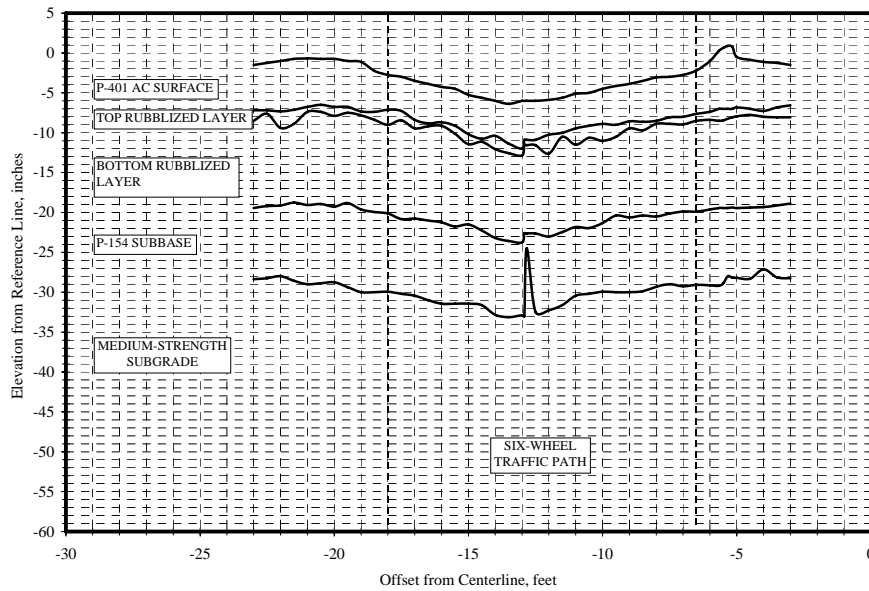
FIGURE 32

For the ARC test items, profiles across MRC trenches are depicted in Figure 31, “MRC-E: Layer Profiles” and Figure 32, “MRC-W: Layers Profiles”, and profiles across MRG and MRS trenches are depicted in Figure 33, “MRG: Layers Profiles” and Figure 34, “MRS: Layer Profiles”, respectively. The trench profiles confirm that the failures in the MRC test items were more severe than in the MRG and MRS test items. The profiles provide further support that the MRC sections can be considered as failed with respect to the classic definition of subgrade failure for flexible pavement design.

MRC-W: LAYER PROFILES

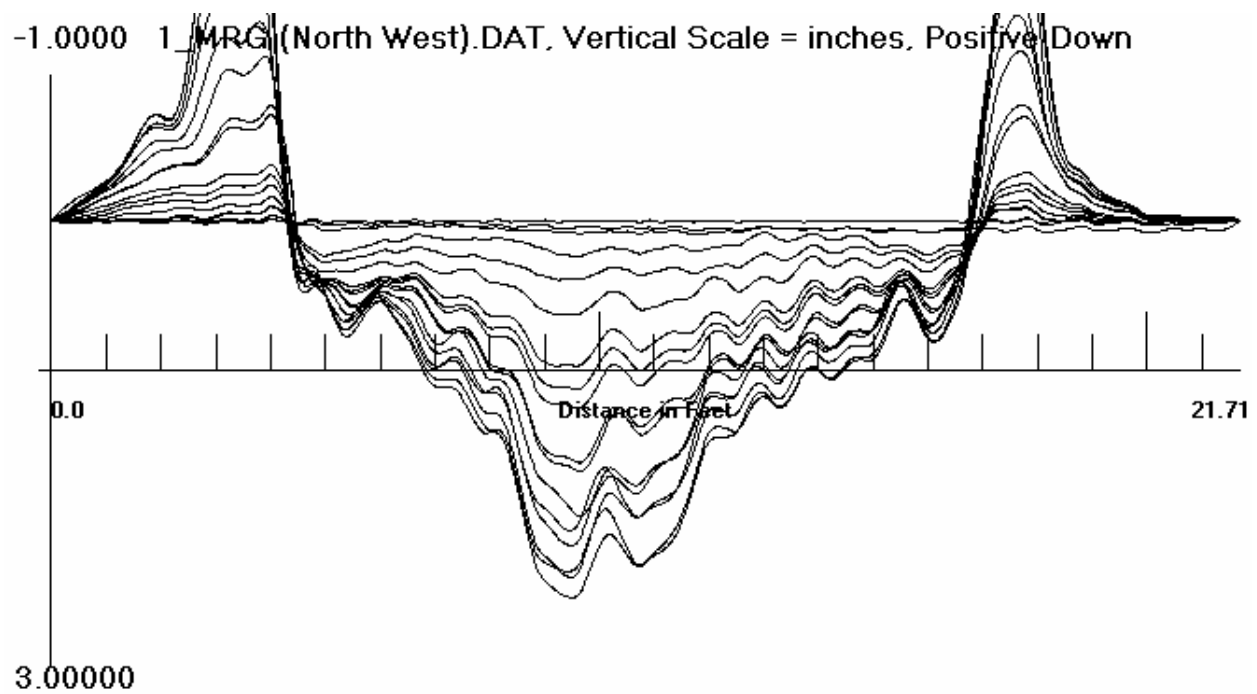
Profile plots across the width of the test items can be found in Appendix A.4. The plots also show the progressive accumulation of rutting with increasing load repetitions.
