Evaluation of NDT Technologies to Assess Presence and Extent of Delamination of HMA Airfield Pavements

Volume I: Technical Report

**Conducted for
Airfield Asphalt Pavement Technology Program
Federal Aviation Administration
AAPTTP Research Project 06-04**

March 2010

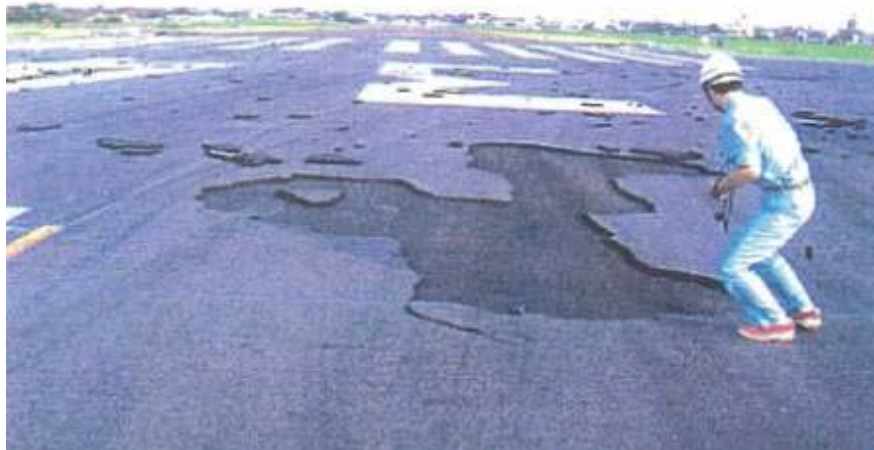
Figure 1.1 – Slippage Failure due to Loss of Bond at Nagoya Airport (from Tsubokawa et al., 2007)

Delamination or debonding problems are particularly more severe on airfield pavements, due to higher traffic loads applied by aircrafts. Especially, the situation is more critical on runways at the high-speed taxiway exits, where airplanes brake and turn (Bognacki et al., 2007), or on areas under large horizontal load of aircraft at takeoff, creating slippage due to inadequate bonding between the top layer and the layer below. In severe cases, it can lead to runway closures (Tsubokawa et al., 2007). As an example, Figure 1.1 shows a case of asphalt delamination that occurred due to loss of bond between the surface and binder courses for a runway constructed only one year before the incident. In this case, the thickness of the surface course that suffered delamination was 2 in., the slippage area was 12 ft wide and 25 ft long, and the runway had to be closed for repairs.

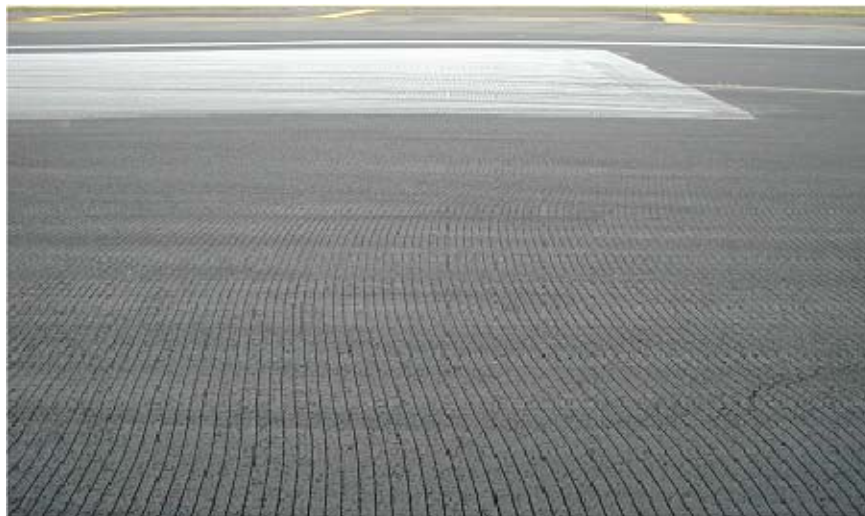
Figure 1.2 – Slippage at High-Speed Taxiway (“Curved” Grooves Indicate Slippage, Bognacki et al., 2007)

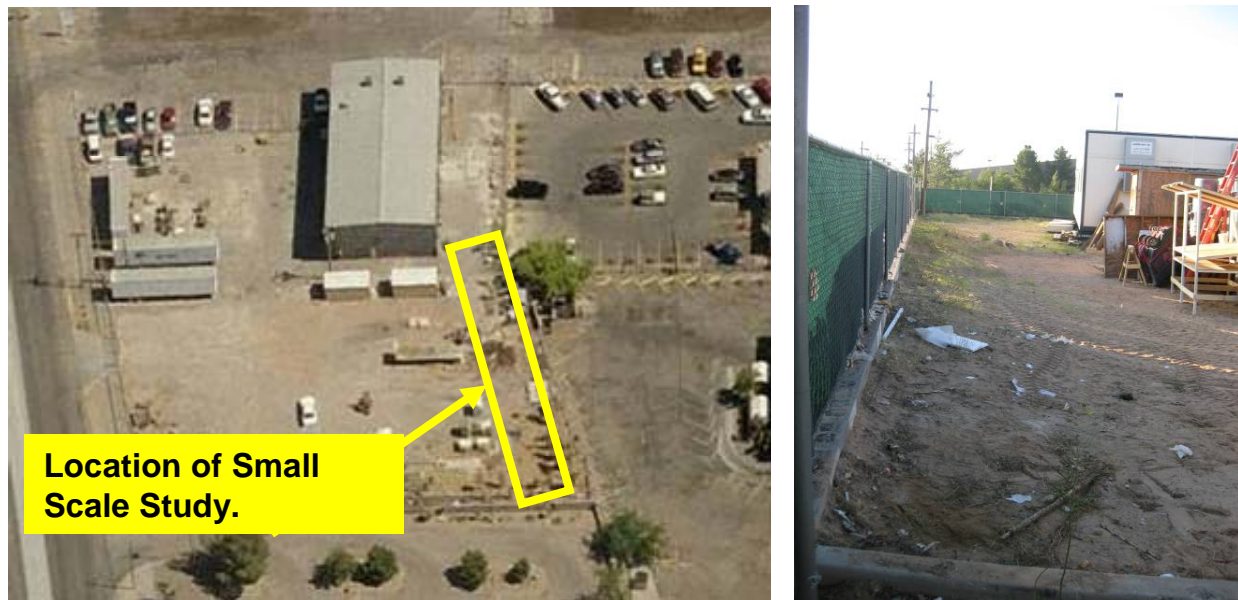
Figure 4.5 – Location of Asphalt Section at UTEP Facilities

Details on the construction of the test section can be found in Appendix C. Ten different sections were constructed in a vacant lot within UTEP property, as shown in Figure 4.5. The final layout of the sections is depicted in Figure 4.6. Each section was 9 ft long (2.7 m) by 10 ft (3 m) wide. Three transition zones were incorporated [a 10 ft (3 m) section before Section 1, a 15 ft (4.6 m) section between Sections 5 and 6 and a 10 ft (3 m) section beyond Section 10] to minimize the variability of the laid down mix during construction.

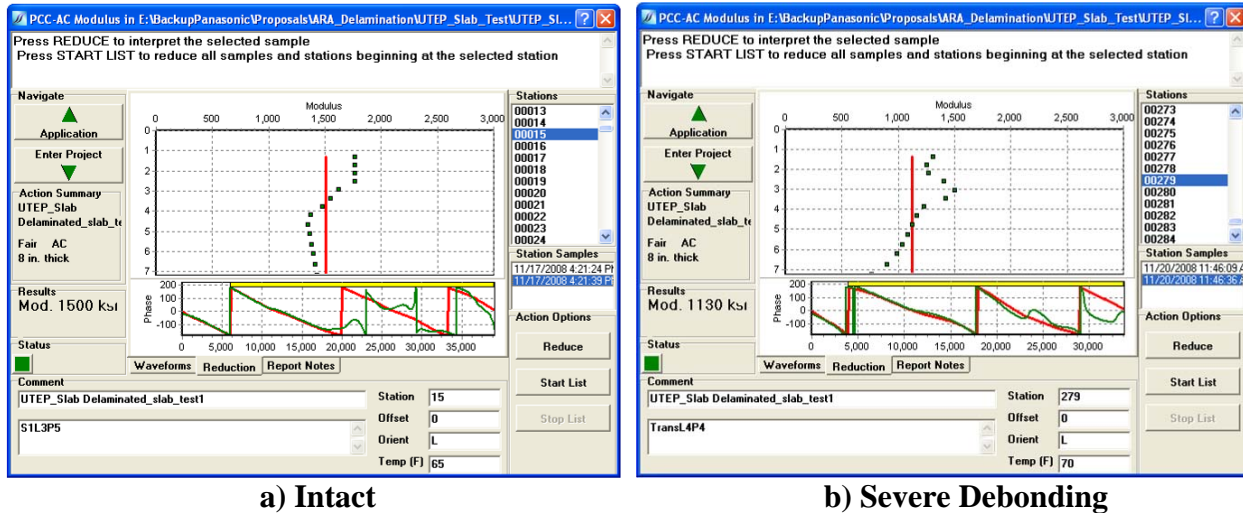
a) Intact **b) Severe Debonding**
Figure 5.4 – Dispersion Curve Results with PSPA on Controlled Study

The vertical red lines in the graphs demonstrate the average moduli of the HMA layer from close to surface (1 in., 25 mm) to 8 in. (200 mm, nominal thickness of the layer). As reflected in the left hand side of the two graphs, these average moduli are about 1500 ksi (10 GPa) for the intact and 1130 ksi (7.8 GPa) for the damaged areas.

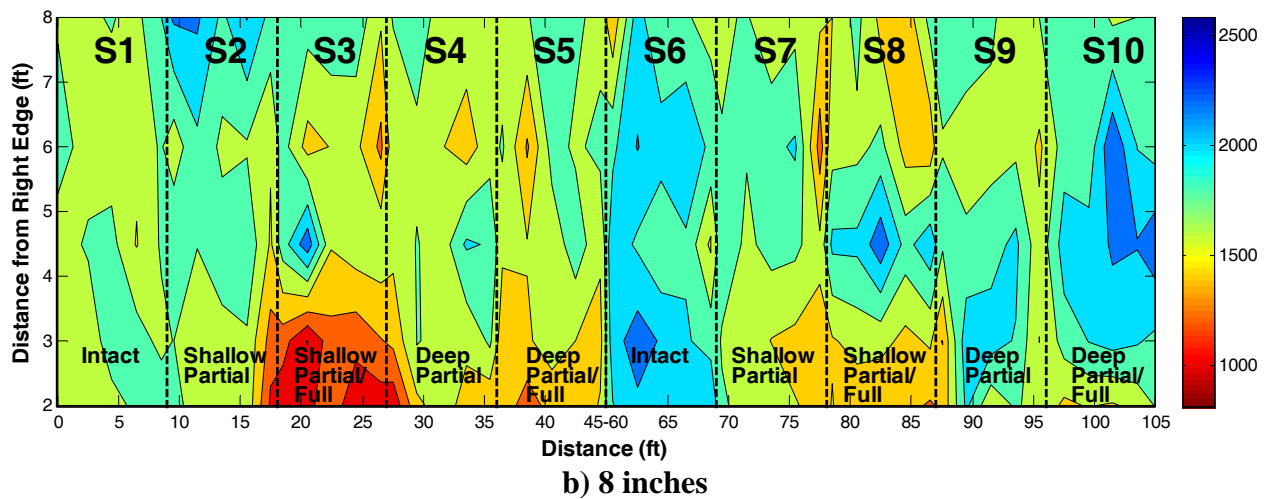
Figure 5.6 – Overall Modulus Results (Top View) on Controlled Study

The average moduli for the top 2.5 in. (63 mm) of the ten sections are shown in Figure 5.6a. Some indication of debonding is observed on the prepared damaged areas, particularly for Sections 3 and 5 (coarse mixes). On the sections prepared with fine mix, the reduction of modulus is smaller on the debonded areas. For the transition area, similar findings are obtained as detailed in Appendix D. When the overall thickness of 8 in. (200 mm) was considered, the

Color Code	Modulus Value	Interpretation
Green	$E > E_{\text{control}} - \sigma_{\text{control}}$	Measured modulus is similar or higher than modulus from control section
Yellow	$E_{\text{control}} - \sigma_{\text{control}} > E > E_{\text{control}} - 2 \sigma_{\text{control}}$	Measured modulus is somewhat less than control modulus
Red	$E < E_{\text{control}} - 2 \sigma_{\text{control}}$	Measured modulus is substantially less than control modulus

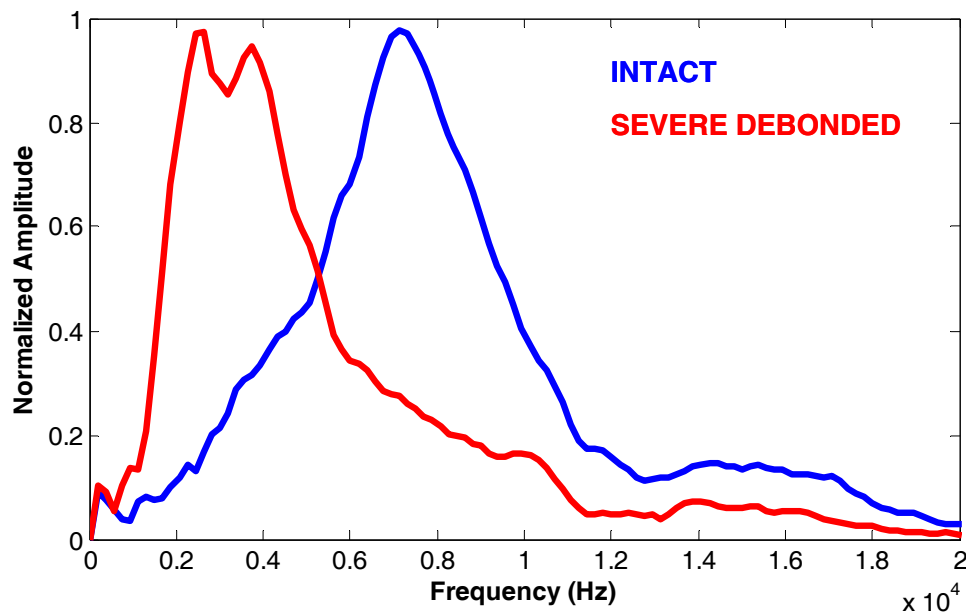
Figure 5.8 – IE Results with PSPA on Controlled Study

The IE method is based on detecting the resonance frequency of the standing wave reflecting from the bottom and the top of a pavement layer. The IE results are illustrated in Figure 5.8 for intact and severely debonded locations. The normalized amplitude of the frequency response on the PSPA receiver closer to the source was used. To obtain the frequency response, a Fast Fourier Transform (FFT) algorithm was applied to the time records from PSPA. For the case of the intact location, only a peak around 6800 Hz dominates the frequency spectrum. For the case of severe debonding, there is a shift to a lower frequency because a flexural (drum like) mode dominates the frequency response of the incident wave on the asphalt.

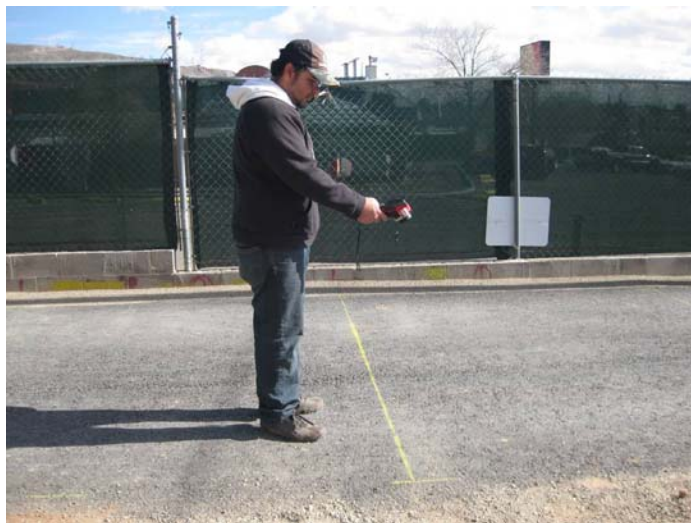
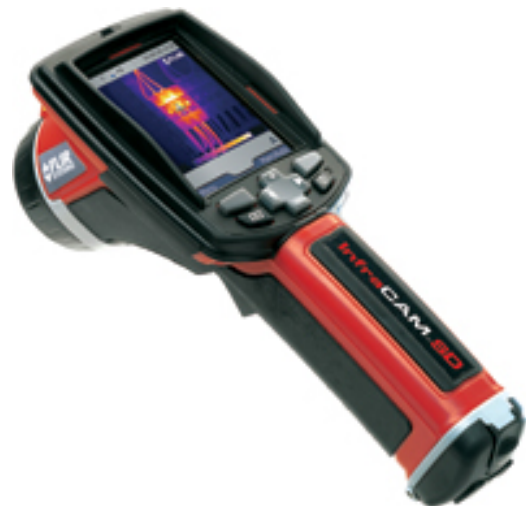
Figure 5.31 – Infrared Camera on Controlled Study

An InfraCAM™ SD from FLIR systems was used to evaluate the thermal method as shown in Figure 5.31. The camera collects thermal images of a surface area of approximately 2 ft by 2 ft (0.6 m by 0.6 mm) when the camera is used at a height of approximately 4 ft (1.2 m) from the surface. The camera operates on a range of temperatures from 14°F to 660°F (-10°C to 350°C). The operator aims a laser pointer to the surface of the pavement and collects and stores an image of 240x240 pixels. The time needed to collect and store an image is typically 20 seconds.

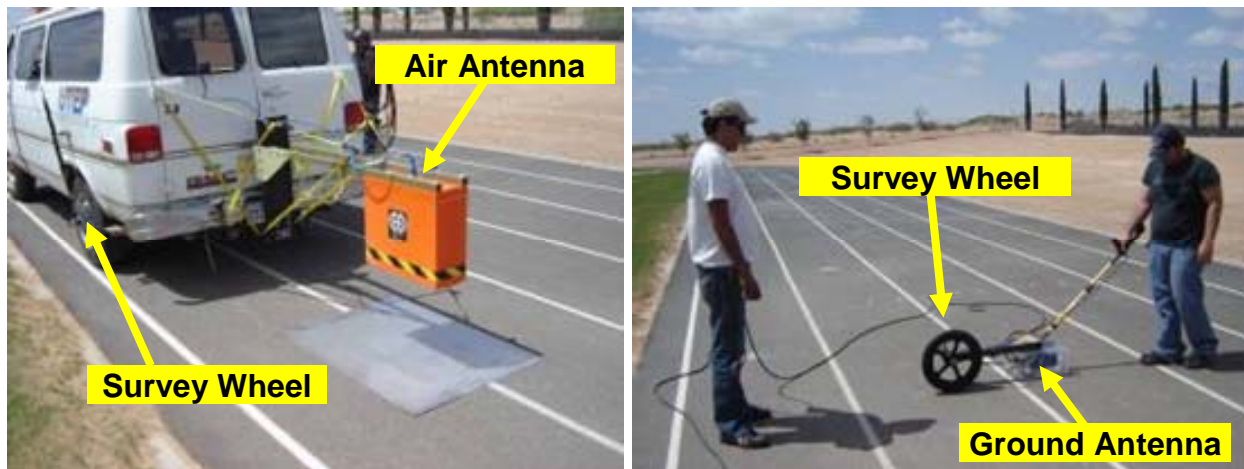
Figure 5.34 – Air Launched (Left) and Ground Coupled (Right) GPR Units

Ground Penetrating Radar (GPR) is a geophysical nondestructive technique that uses electromagnetic pulses to test, characterize, or detect subsurface materials based on changes in electromagnetic properties of the subsurface layers. Typical equipment setups for GPR surveys are shown in Figure 5.34 for air-launched and ground coupled systems.

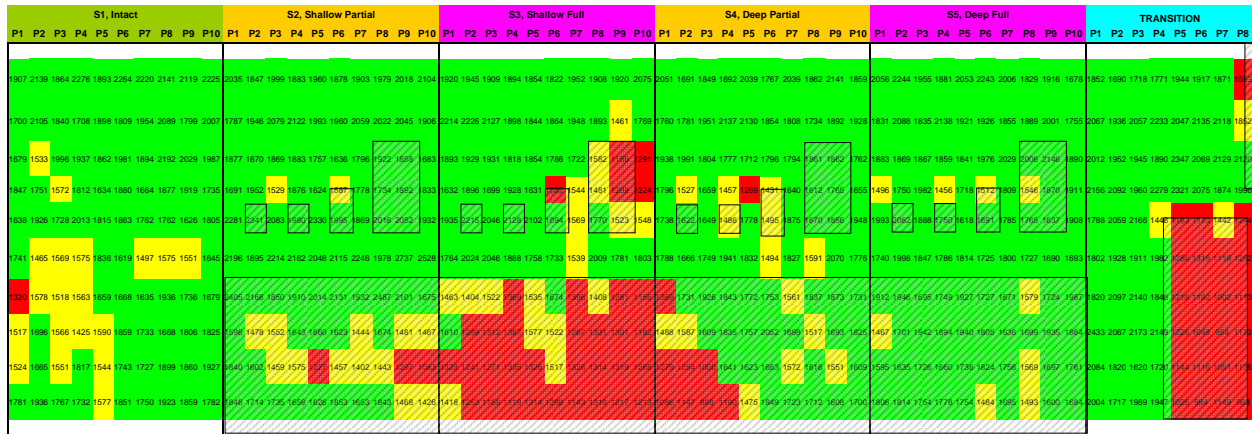
Figure 6.5 – Temperature-Adjusted Contour Maps of PSPA Modulus in Cool Weather

The results after temperature adjustments with Equations 6.1 and 6.2 are shown in Figures 6.5 and 6.6. The outcomes are in general similar to those in Figures 6.2 and 6.3. For the cool weather data (Figure 6.5), the resolving power for the fine mixes improved for Sections 9 and 10 (corresponding to the deep debonding). On the other hand, the manifestations of the shallow partial debonding are not obvious for Section 7 after temperature adjustment in hot weather testing (Figure 6.6). This activity indicates that the default temperature adjustment in Equation 4.1 is adequate and that the lack of detection of debonding on some of the sections is related to the shortcomings of the method. Also, the development of a temperature-modulus adjustment relationship as part of the protocol for PSPA tests may be desirable.

Based on the revised criteria, color-coded moduli are presented in Figure 6.7 and 6.8. These results are comparable to those in Figures 6.5 and 6.6. From this point forward, the revised criteria will be applied for presenting the results.

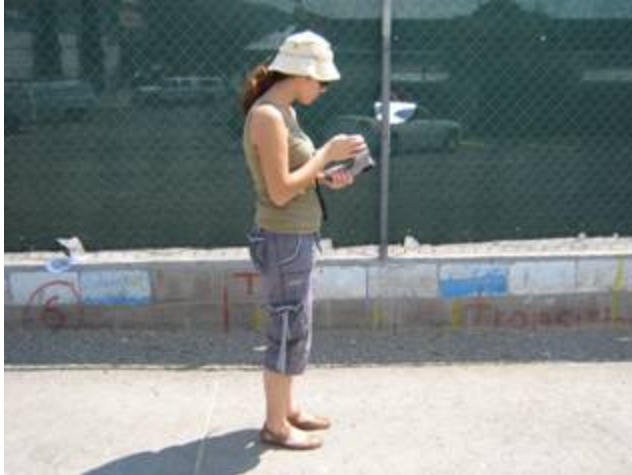
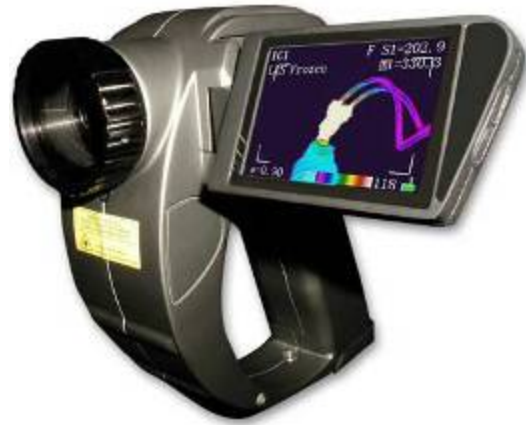
Figure 6.26 – Infrared Camera on Controlled Study

The thermal imaging was not deemed successful in Chapter 5. One concern with the earlier survey was the resolution of the camera. A more sensitive camera (a ToughCam Pro from Infrared Cameras Inc.) was acquired and used to reevaluate the thermal method as shown in Figure 6.26. A study was conducted on the transition section to evaluate the feasibility of the more sensitive camera. A total of 120 pictures were obtained, each one covering an area of 1 by 1 ft approximately. The combination of all the pictures is presented in Figure 6.27. Areas of

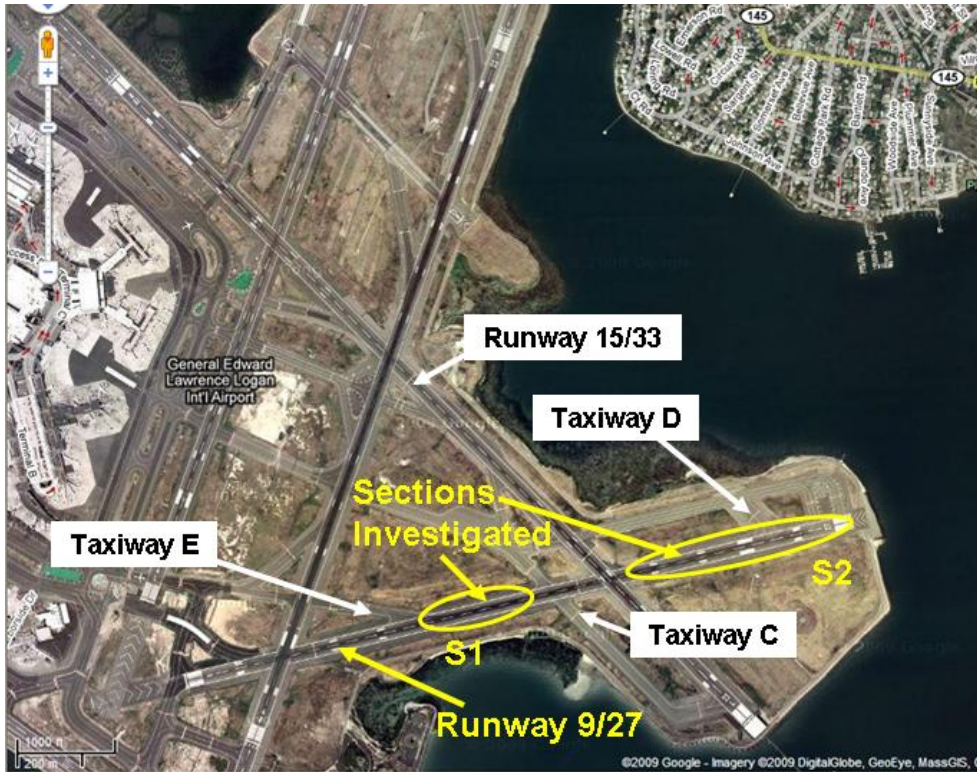
Figure 7.21 – Schematic of BOS and Location of Test Sections

A stretch of Runway 9-27 was tested with several NDT methods concurrent with its rehabilitation in July 2009. Based on previous studies conducted on Runway 9-27 in January 2009, several areas exhibited debonding of the top lift, and in occasions, areas of extreme stripping. Two sections were selected for field testing. Section 1 was located between Taxiways E and C and Section 2 between Runway 15/33 and Taxiway D as illustrated on Figure 7.21.
